BTR Engineering [Australia] Limited

**BTRE
FOUR SPEED ELECTRONIC
AUTOMATIC TRANSMISSION
DEALER TRAINING SEMINAR
REVISION IV**

AUGUST 1994

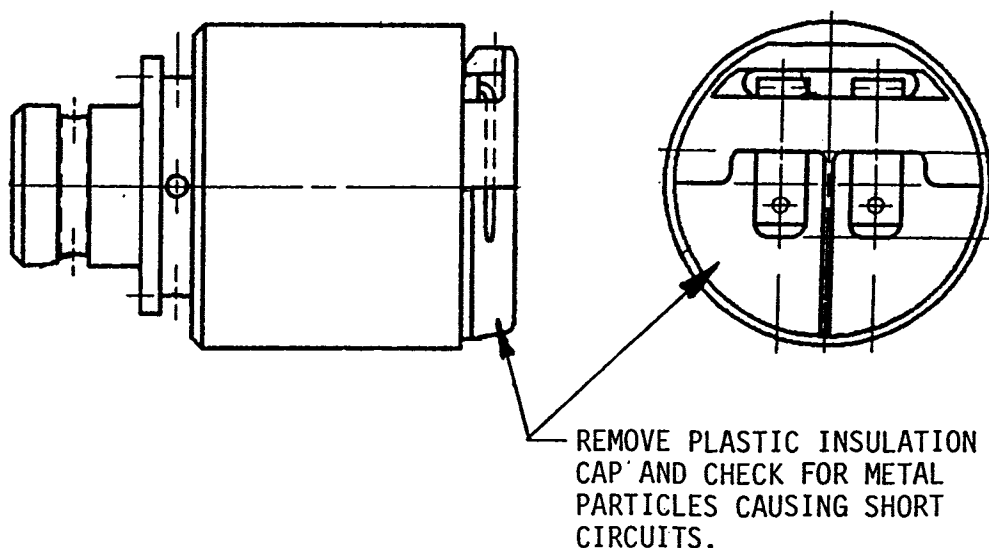
FIGURE 1: ON/OFF SOLENOID FAULT DETECTION.

Note: that solenoids act as magnets and will therefore attract ferrous particles.

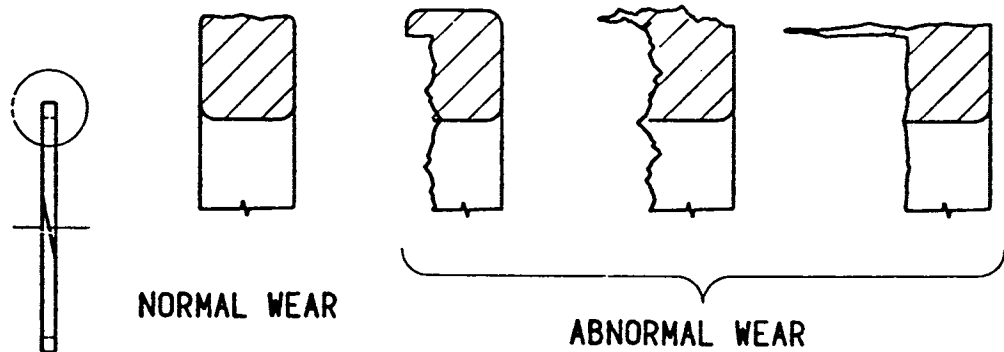
It is important when one or more sealing rings are encountered which have a similar abnormal wear pattern to that shown below, that the shaft on which they sit (input, overdrive, or output) be replaced concurrently with the seals.

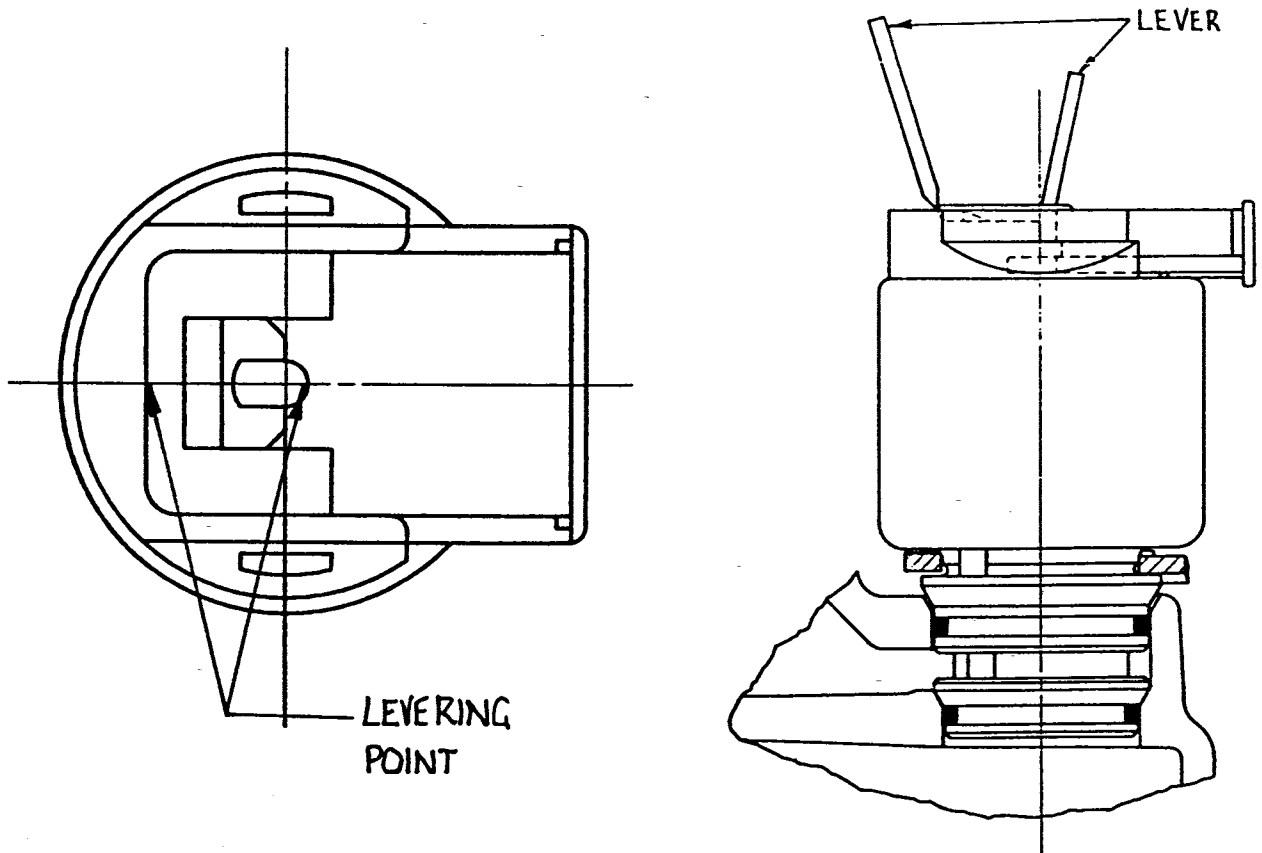
FIGURE 1 Unacceptable removal method using levers

FAULT: It has been noted that the MkII solenoid wiring loom connectors are susceptible to damage if removed from the solenoid using a lever, as shown in figure 1. The use of a lever in either of the positions shown can result in breakage of the "U" leg on the connector and thus reduce the retention capacity of the connector.

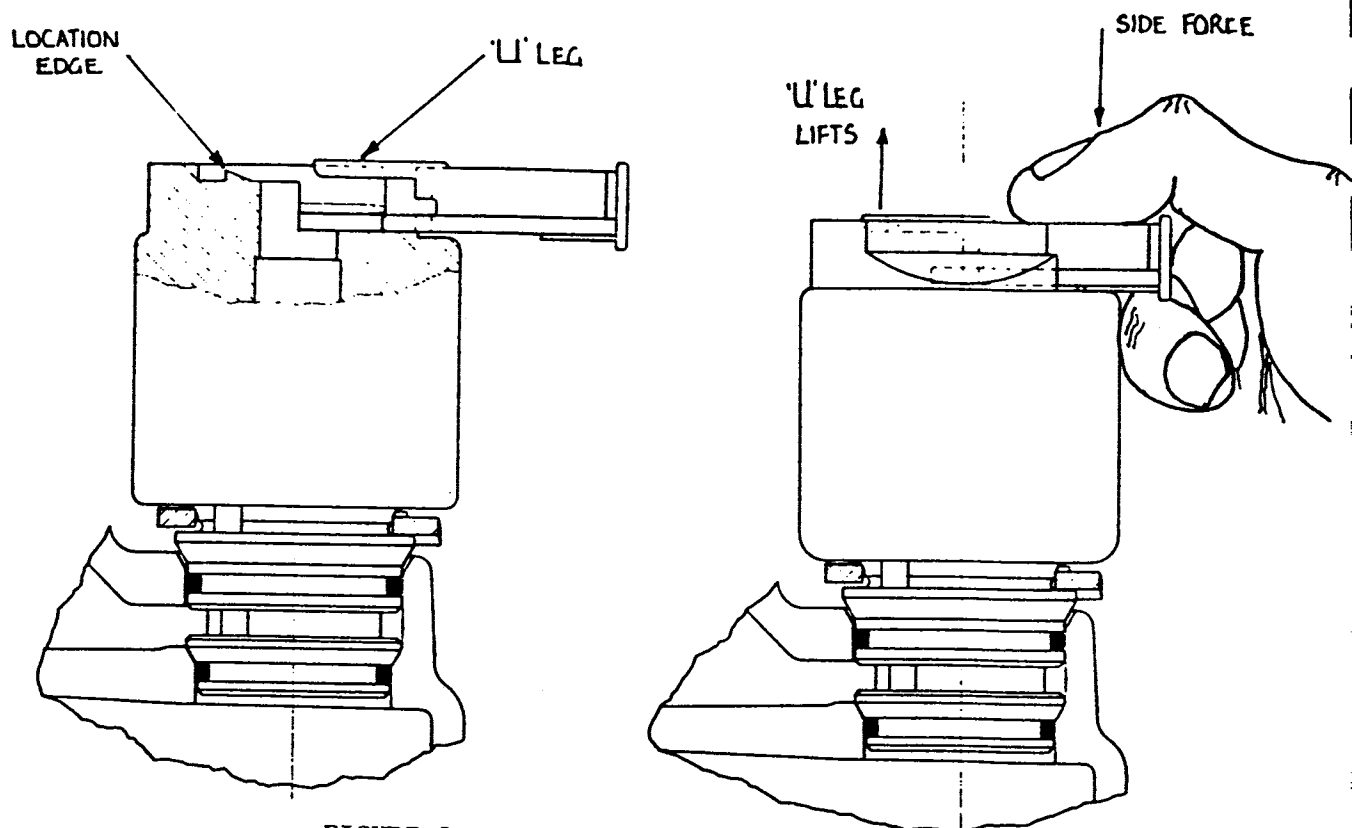
FIGURE 2 Acceptable removal method

leg from the location edge. Experience shows that the terminal connector is easily removed by hand when removed as shown.
