BTR Engineering [Australia] Limited

**BTRE
FOUR SPEED ELECTRONIC
AUTOMATIC TRANSMISSION
DEALER TRAINING SEMINAR
REVISION IV**

AUGUST 1994

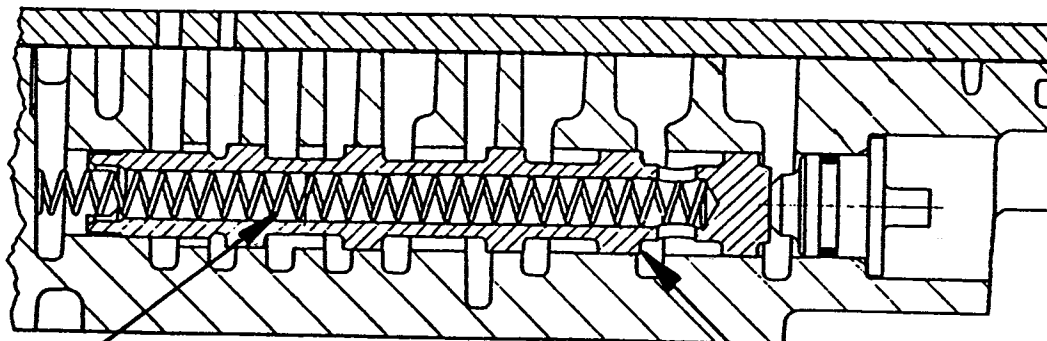
Transmissions built before 2nd November, 1989 are fitted with converter clutch control valve 0585-237038.

In the event of a transmission rebuild, it is recommended that this valve be replaced with a new valve 0585-237071 and spring 0585-156126 as shown below:

NEW SPRING: 0585-156126

NEW VALVE: 0585-237071

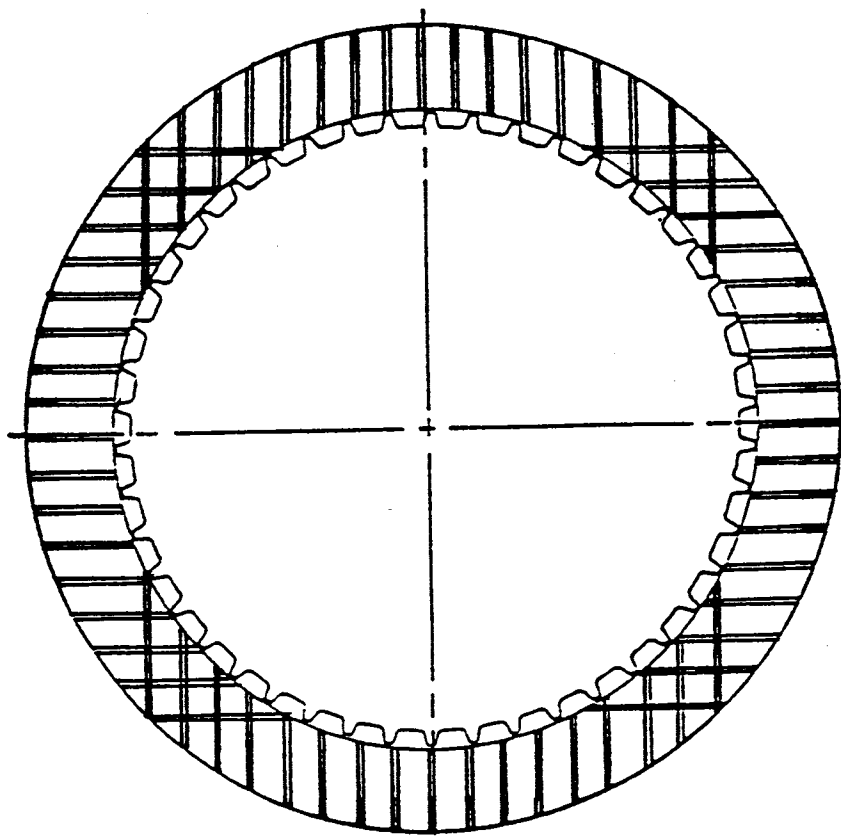
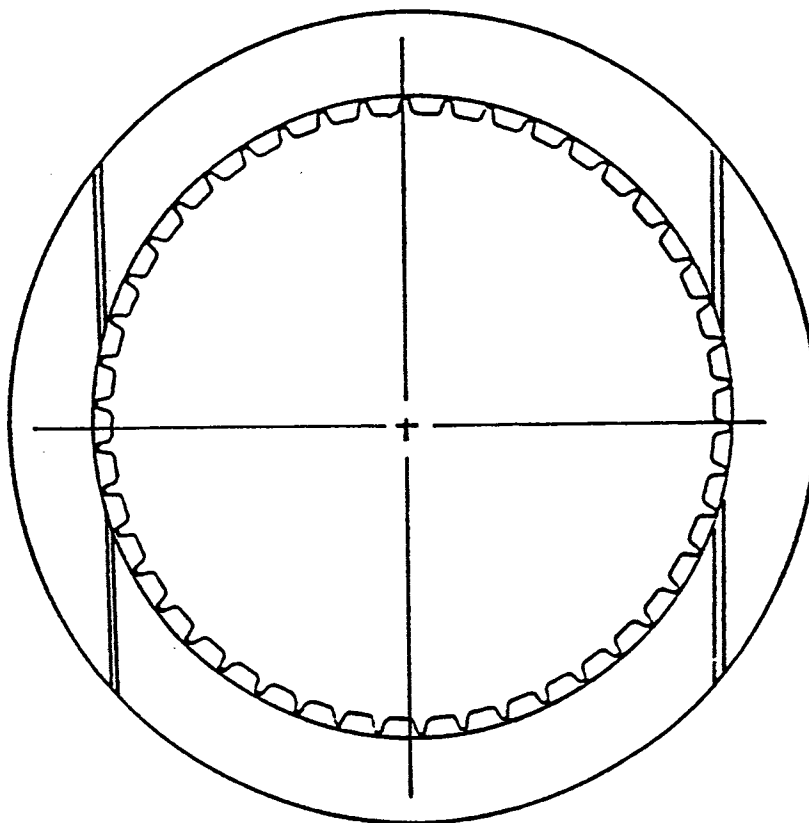
FIGURE 2 - c1, c3 & c4 FRICTIONS

INCORRECT USE OF THESE FRICTION PLATES MAY RESULT IN INADEQUATE TRANSMISSION PERFORMANCE AND EVENTUAL TRANSMISSION FAILURE.

C1, C3 and C4 CLUTCH PACK ASSEMBLIES SHOULD ONLY USE FRICTION PLATES WITH GROOVE DETAILS AS SHOWN IN FIGURE #2.

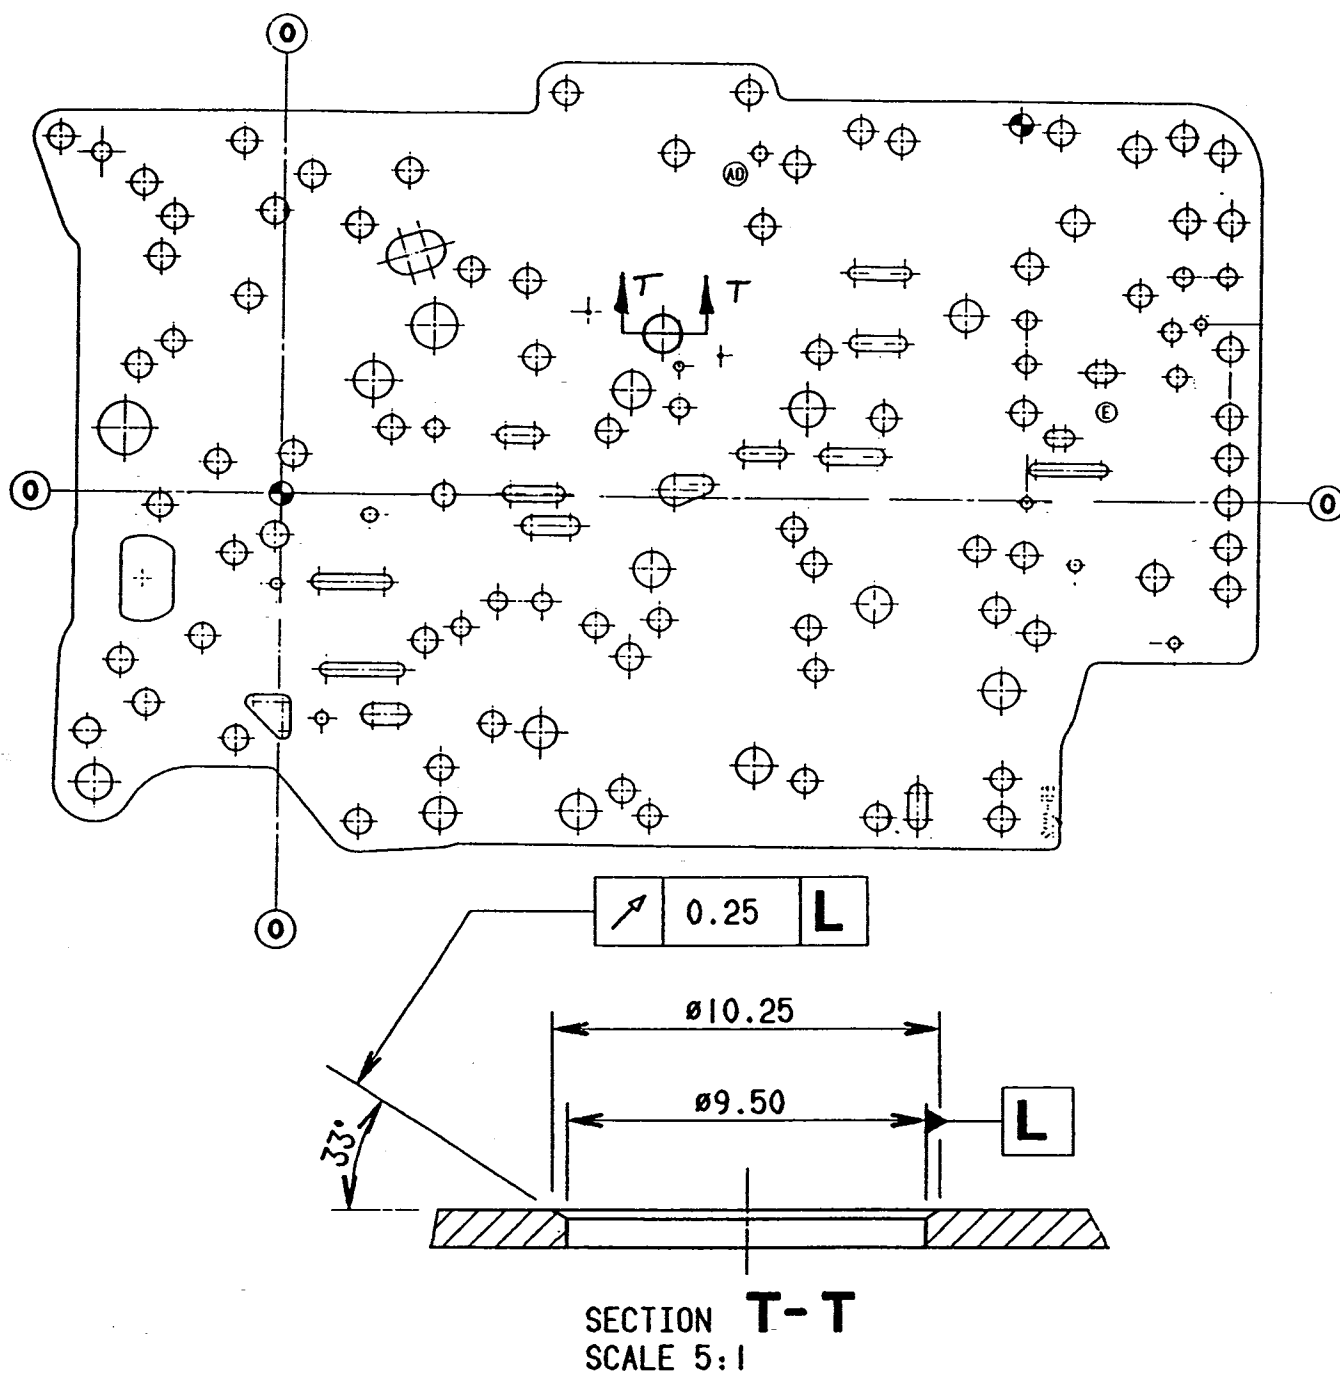
FIGURE 3: CAF HOLE AND 33° CHAMFER.

M85 Transmissions built after the 15th of January, 1990 are assembled with baffle plates having a 33° chamfer on the Ø9.5 CAF hole. Refer Figure 4. This change provides a smooth deburred surface for the ball to seat against, thus preventing wear of the ball.

- i) Replace the CAF ball with a new one if it shows any signs of wear i.e. surface is rough and/or diameter is less than 11.5mm.
- ii) Inspect the CAF hole in the baffle plate. If the hole does not look like the one shown in Figure 3, or the hole edge quality is not smooth and deburred, replace the baffle plate with a new level component. (BTRE Part Number 0585-036002).

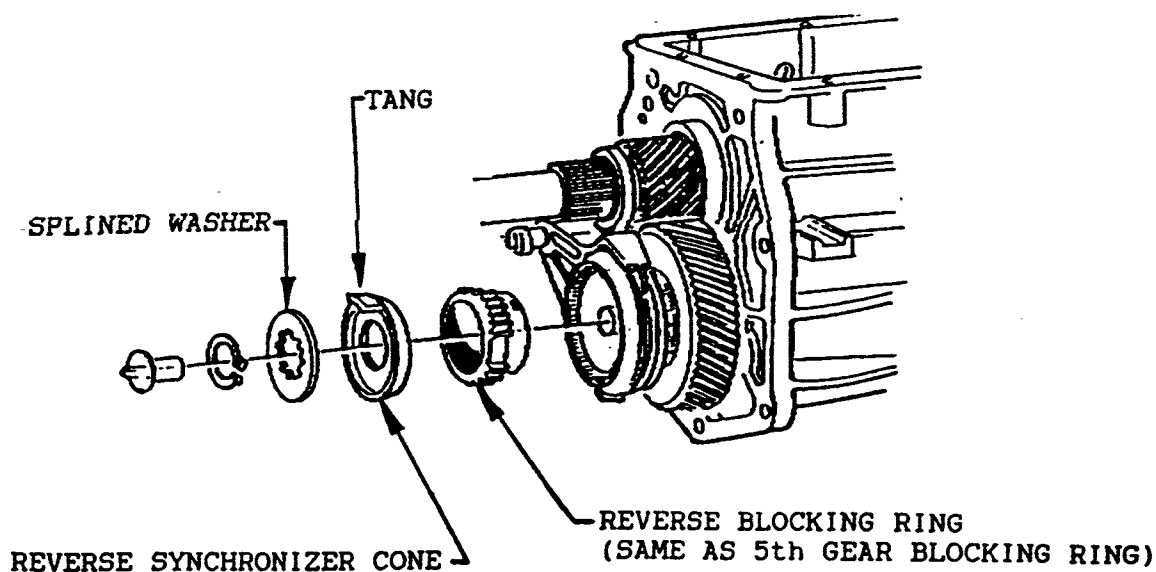
NOTE: TANG ON REVERSE SYNCHRONISER CONE MUST BE LOCATED TO THE TOP (POSITIONED AT 12 O'CLOCK) PRIOR TO FITTING THE EXTENSION HOUSING.

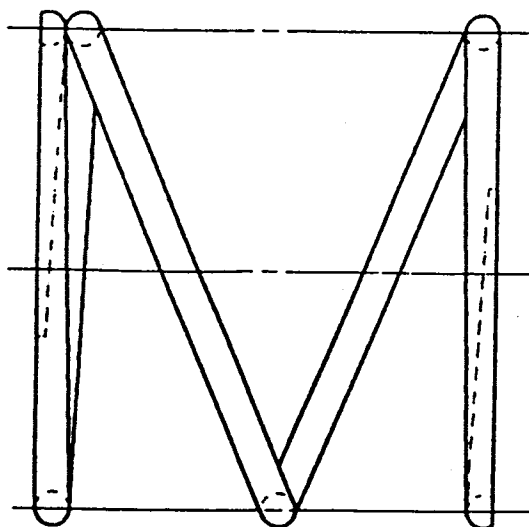
Two springs only (C2/C4 & C3) have their coil helix direction listed in table 4 to further assist identification. Refer Figures 1 & 2. All other springs may be coiled either righthand or lefthand.

Figure #1
C2/C4 Spring (Right Hand Spring).

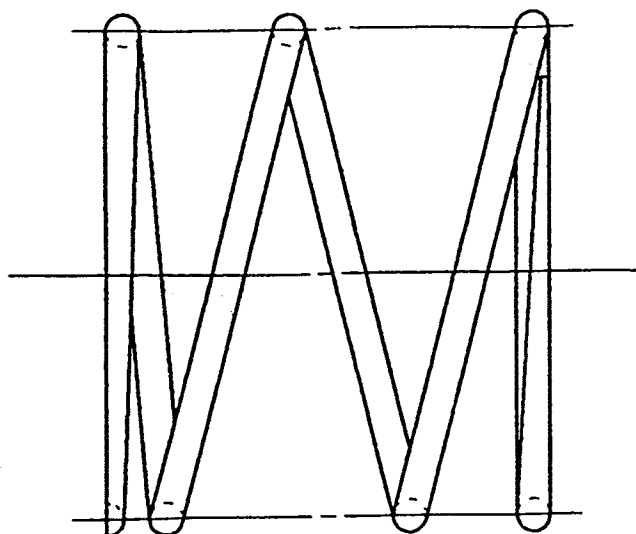
Figure #2
C3 Spring (Left Hand Spring).

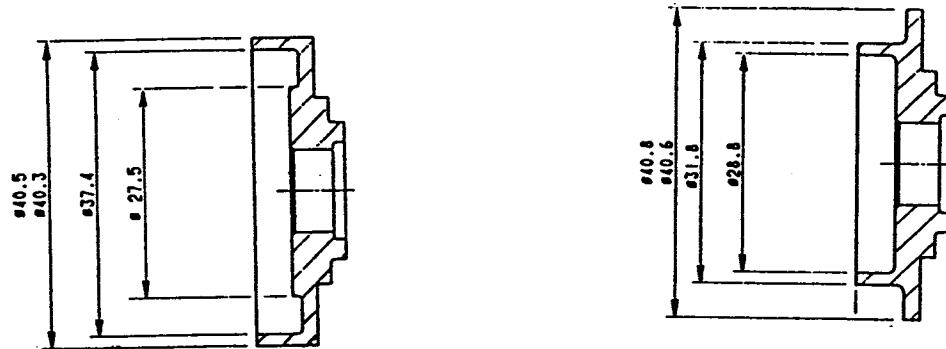
Some transmission failures have occurred due to the front servo block retaining screw and washer becoming loose in the servo cavity.

FIGURE 2: RETAINER (SEAT - SPRING)

Whenever the front servo assembly is disassembled during service, or on rebuild it is recommended that the return spring and retainer are replaced with the new design components.

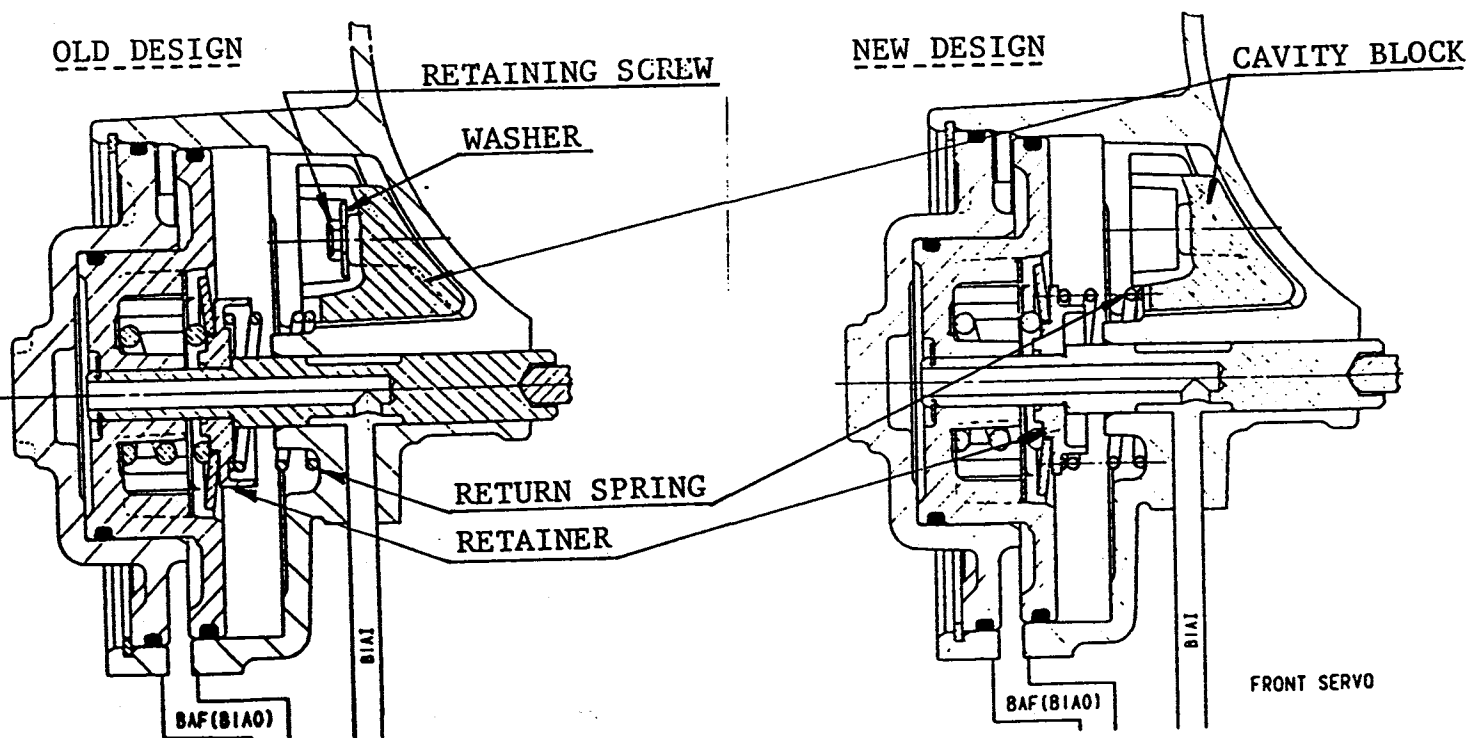
FIGURE 3: RETURN SPRING AND RETAINER ASSEMBLY

NOTE: Cavity block remains the same for all models and old and new retainer spring.

The old style return spring and retainer MUST be used in conjunction with the servo cavity block screw and washer. Failure to do so could result in damage to the front servo piston and a degradation in shift quality.

- c) For the new design return spring and retainer, a retaining screw and washer do not have to be fitted and it is recommended that these parts be removed when the new retainer and spring are installed.

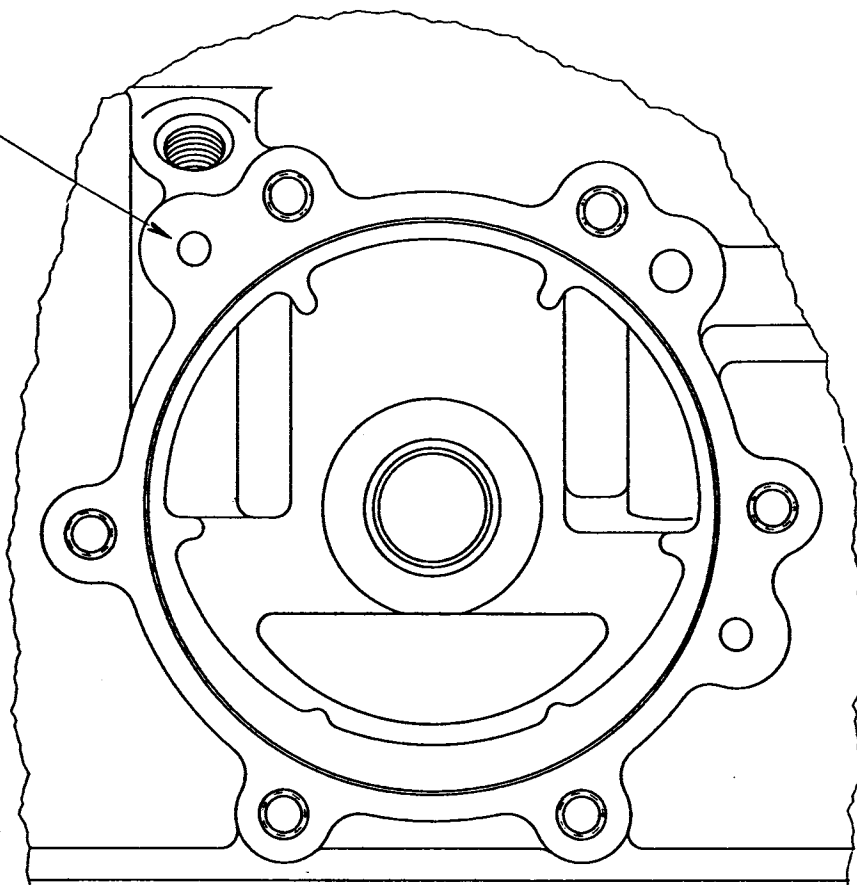
EXTERNAL LUBE
HOLE & BOSS

FIGURE #1, TRANSMISSION CASE,
WITH EXTERNAL LUBE HOLE & BOSS.

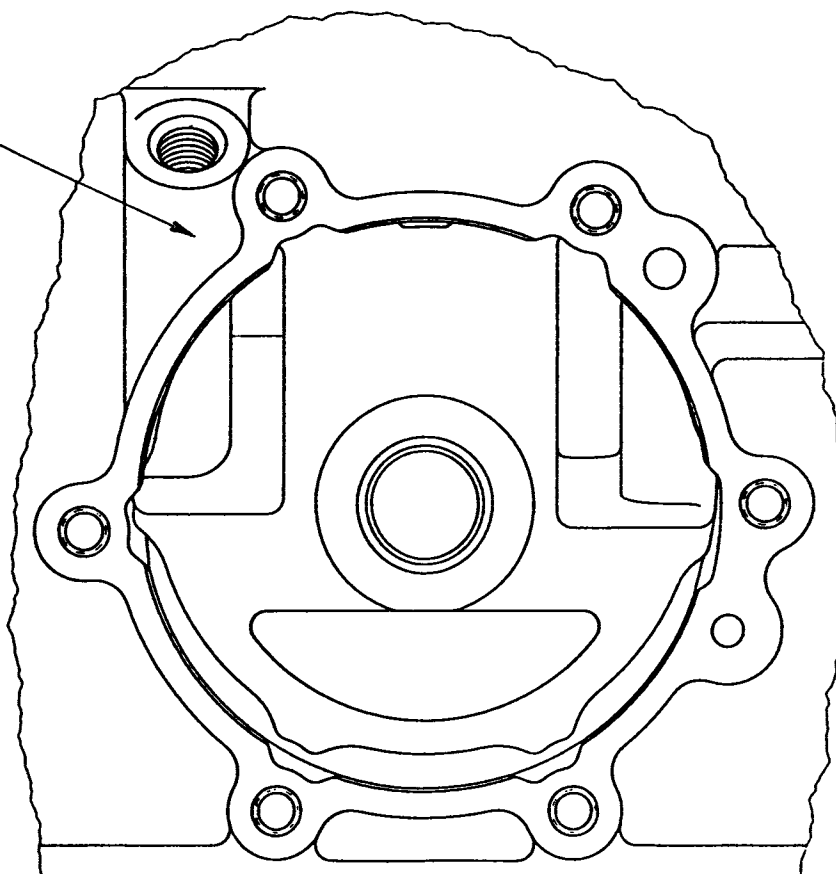
EXTERNAL BOSS
REMOVED.

FIGURE #2, TRANSMISSION CASE,
WITH INTERNAL LUBE DRILLING.

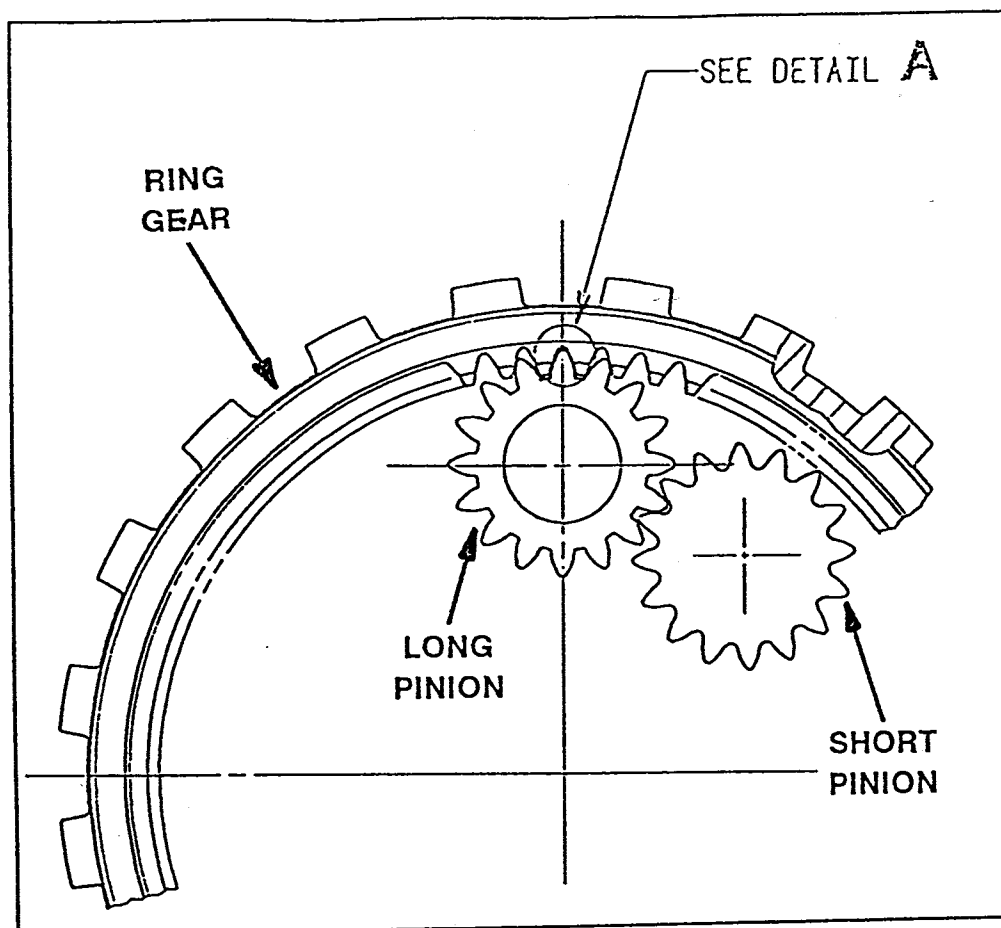
Figure 1 : Sketch of the gears affected by the new gear set design

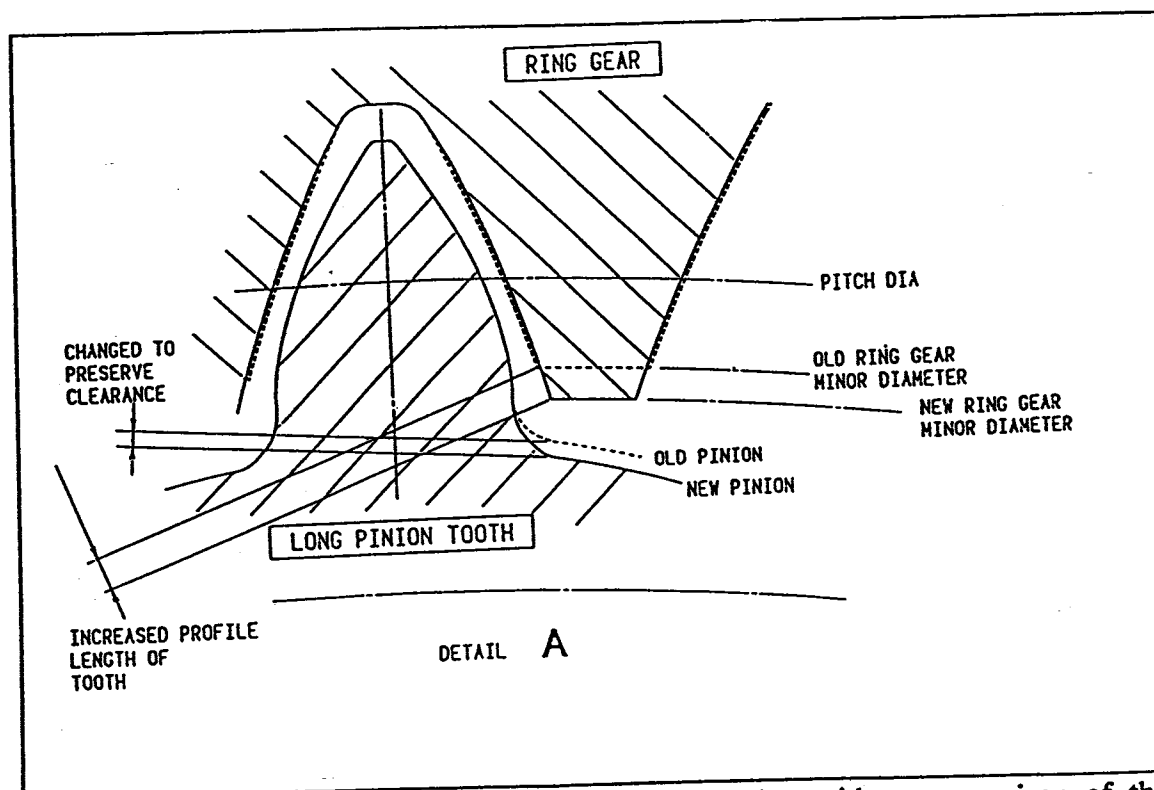
Figure 2 : Detail of new gear design changes together with a comparison of the former gear design

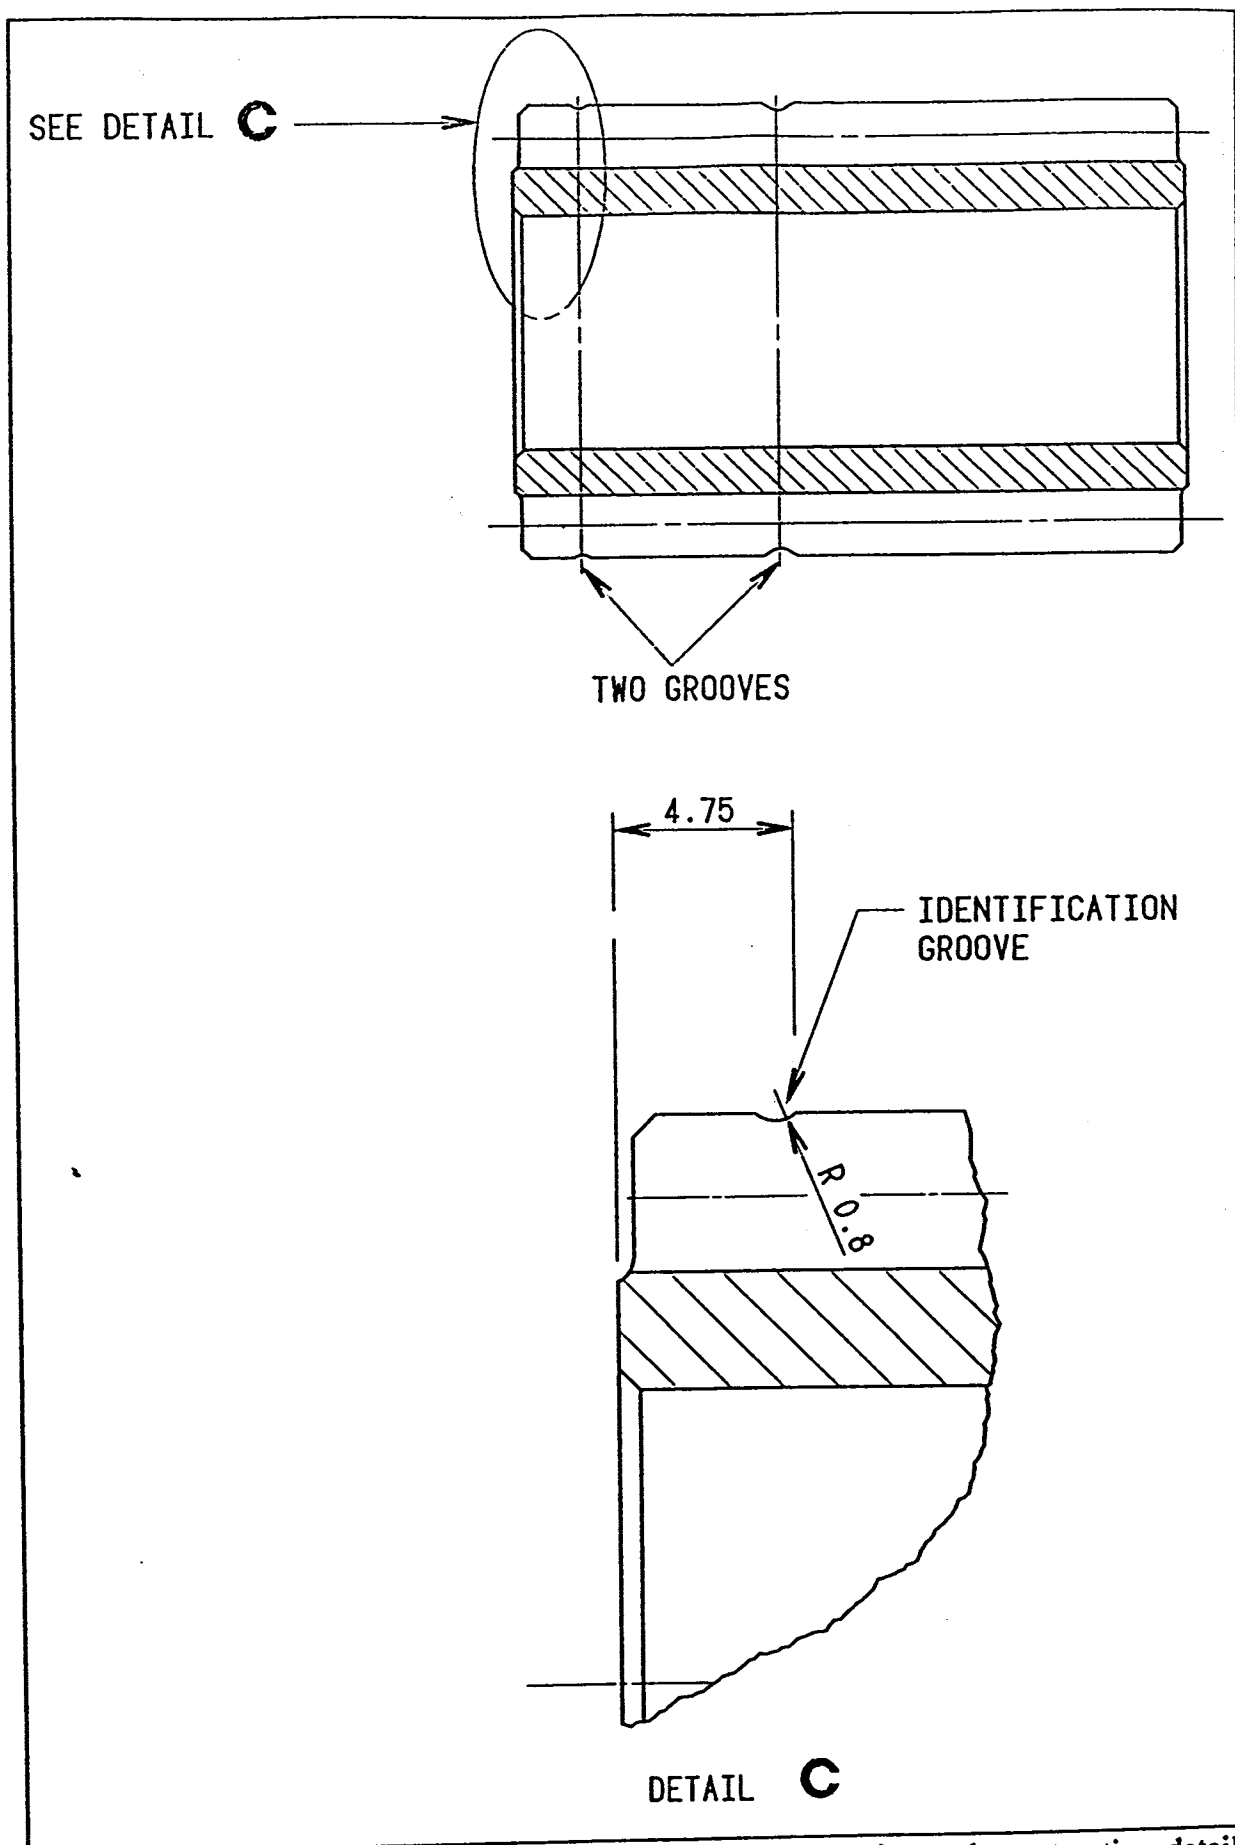
- a. The new long planet pinion has a shallow groove (R 0.8) near an end of the pinion (4.75mm from the end face), refer to Figure 3. This means that the long pinions will have two grooves in total.

Figure 3 : Sketch of the long planet pinion showing the location and construction details of the groove identifying the new design.

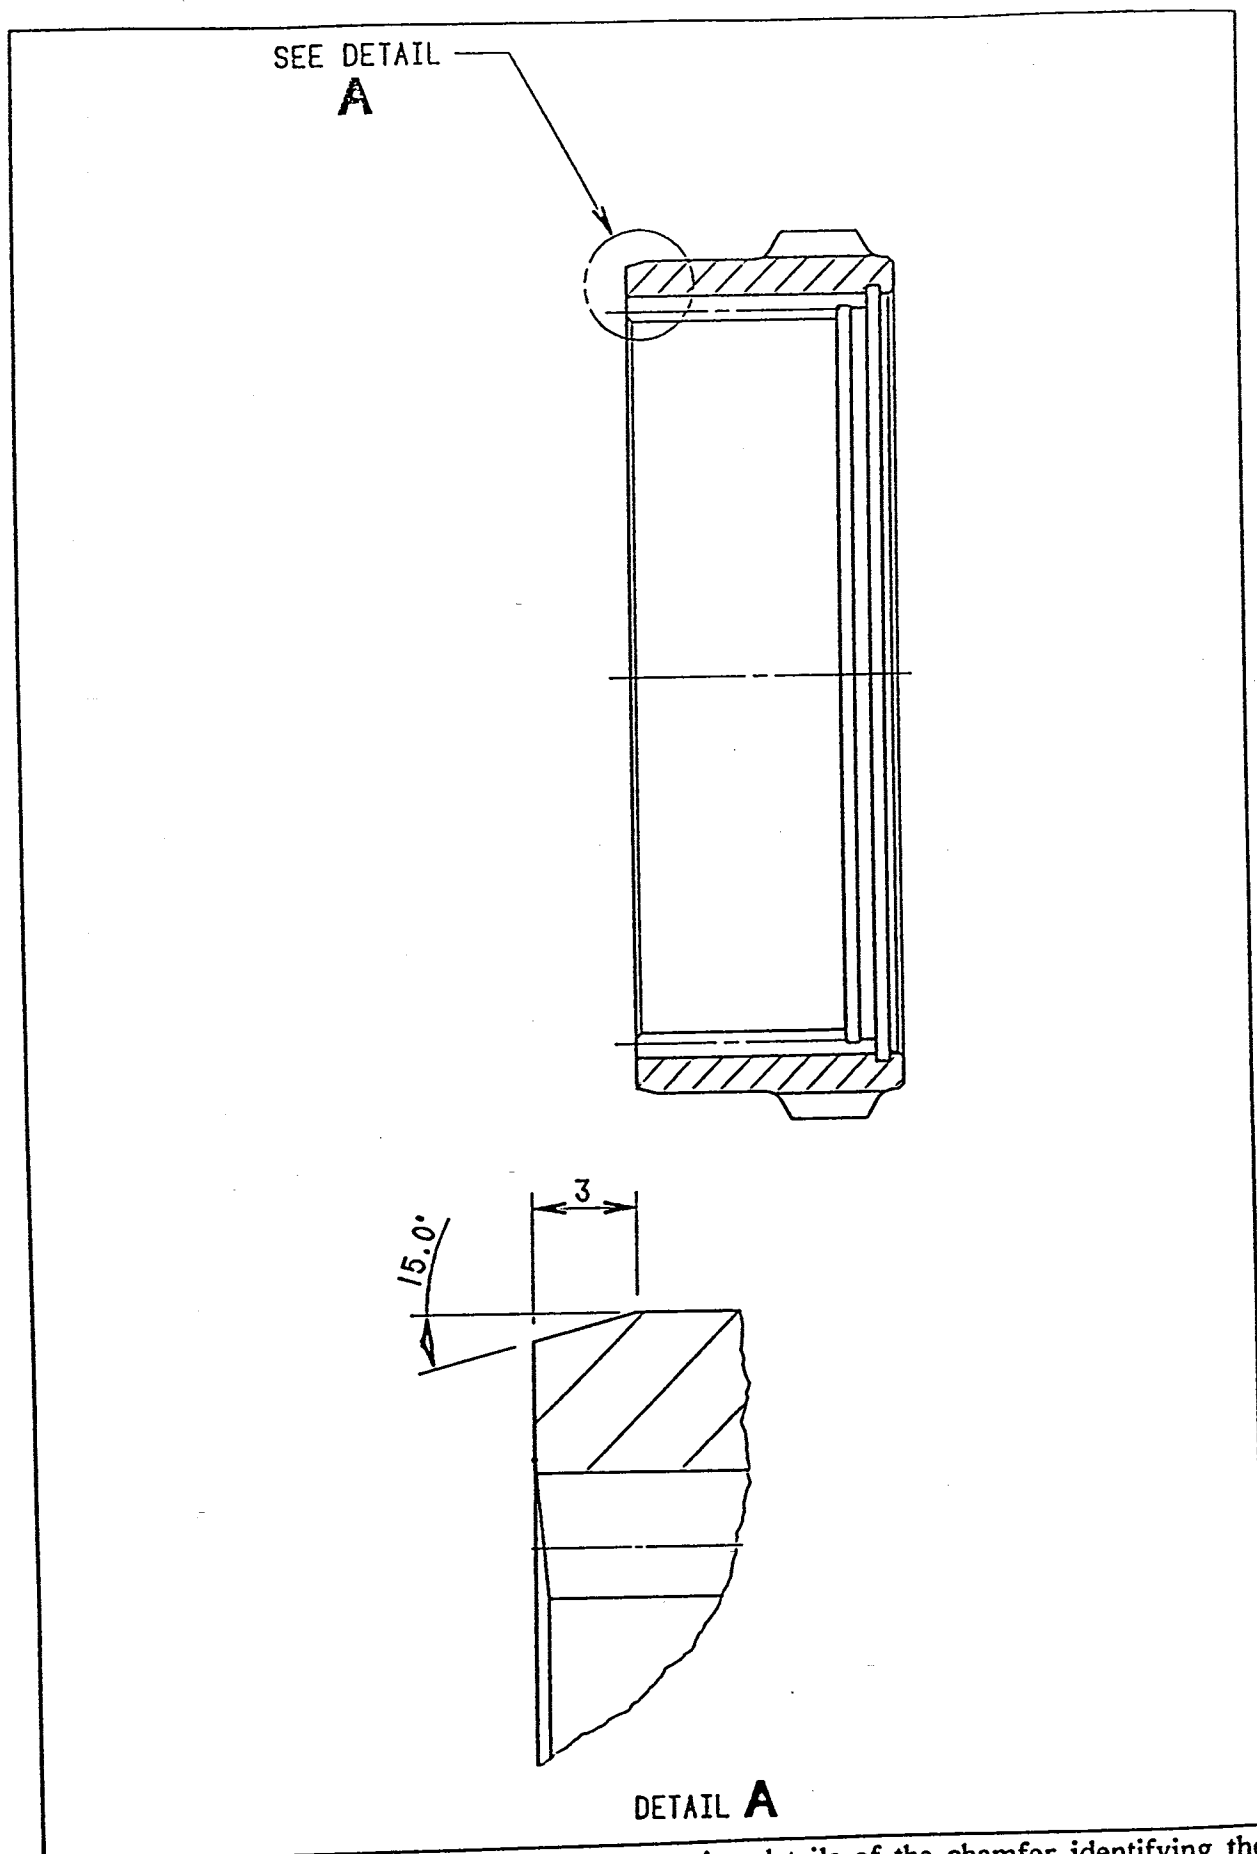
- b. The new ring gear has a large chamfer (3mm x 15°) on the outside diameter in lieu of the former production chamfer (0.8mm x 45°). Refer to Figure 4.
- c. The new output shaft has a radiused groove (R 0.8) in the splines. This groove is 7mm from the end face of the output shaft. Refer to Figure 5.
- d. Short planet pinions are identifiable by their ground outside diameter. Refer to Figure 6.
- e. Planet carrier assemblies featuring the new long and short pinions can be identified by viewing the groove on the long pinion from the open end of the carrier assembly. Refer to Figure 7.

Figure 4 : Sketch of the location and construction details of the chamfer identifying the new design ring gear.

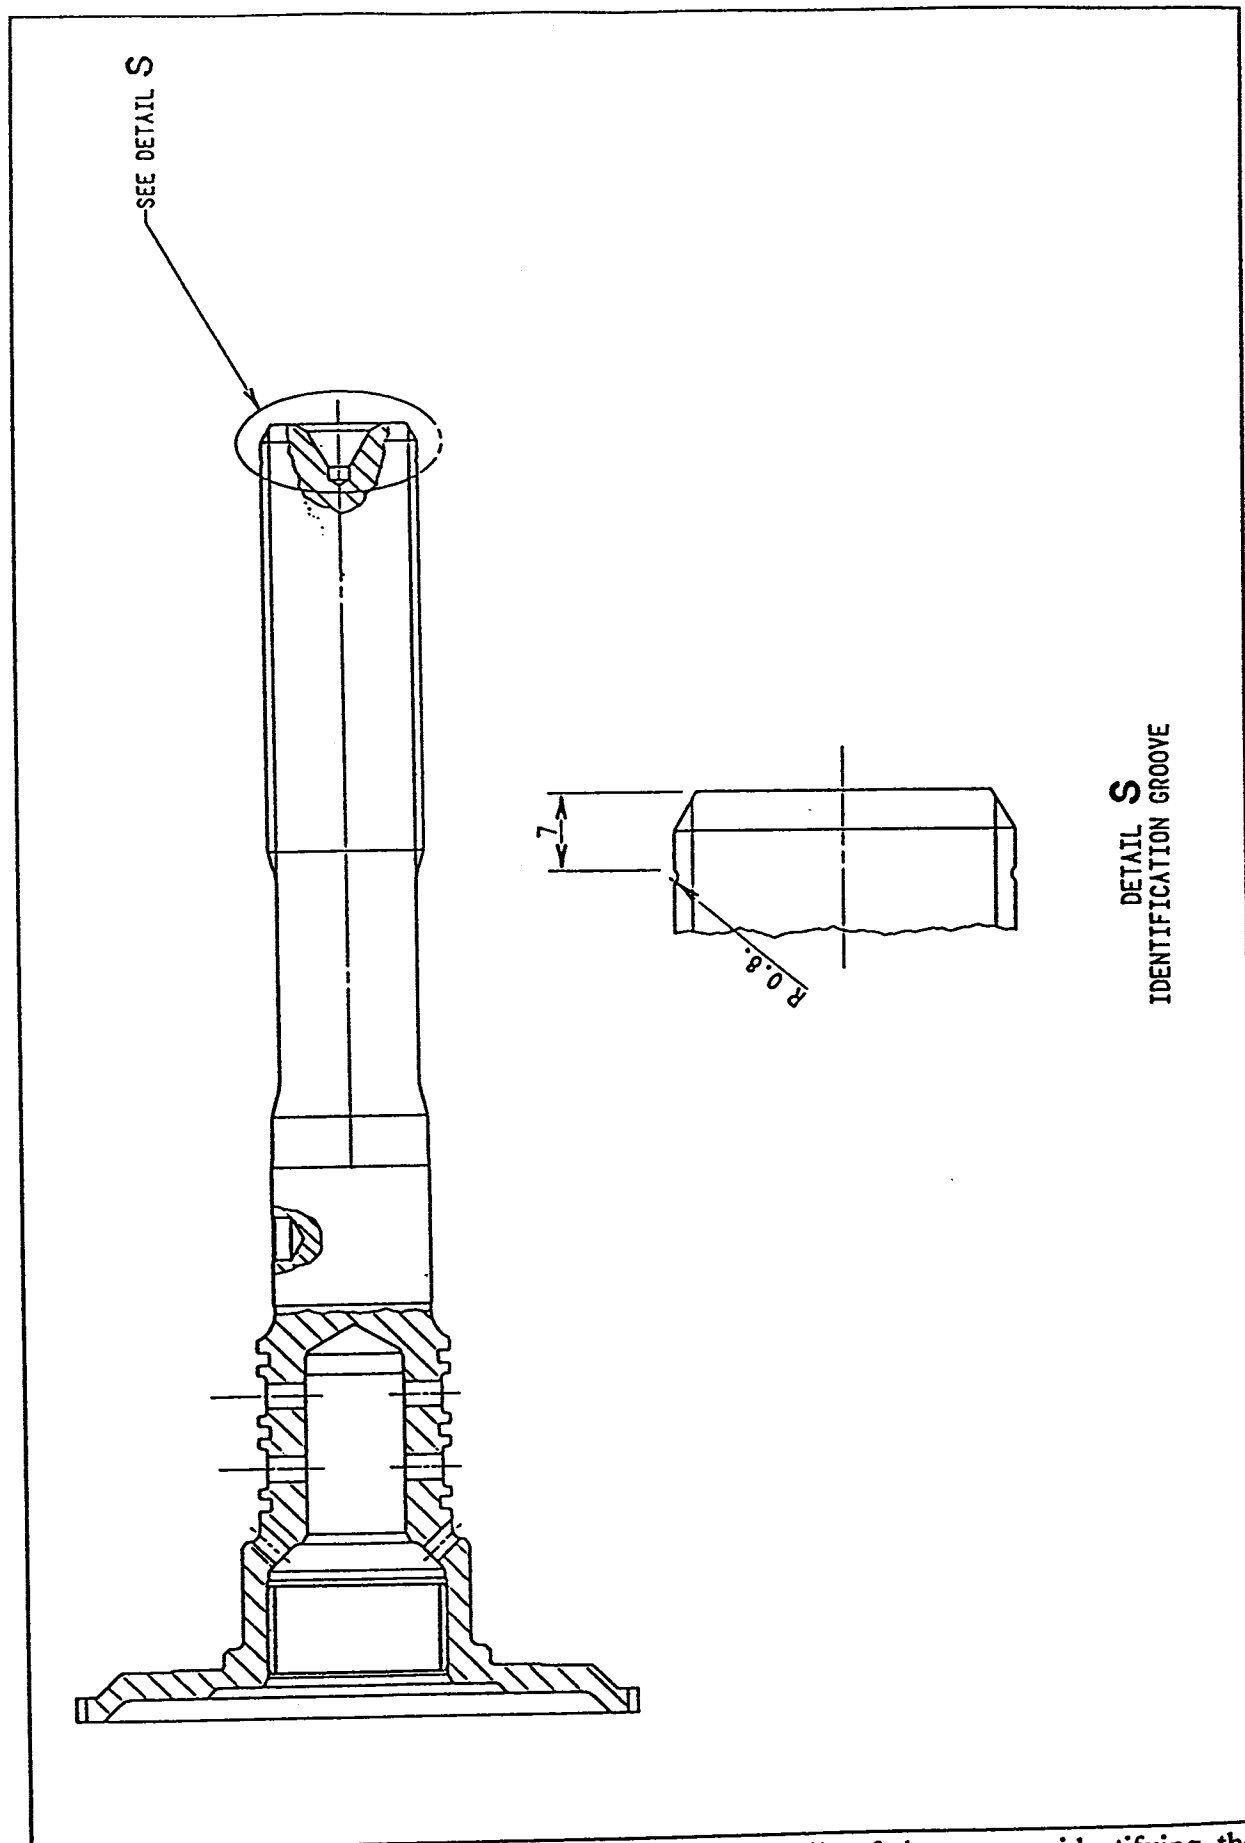
Figure 5 : Sketch of the location and construction details of the groove identifying the new design of output shaft.

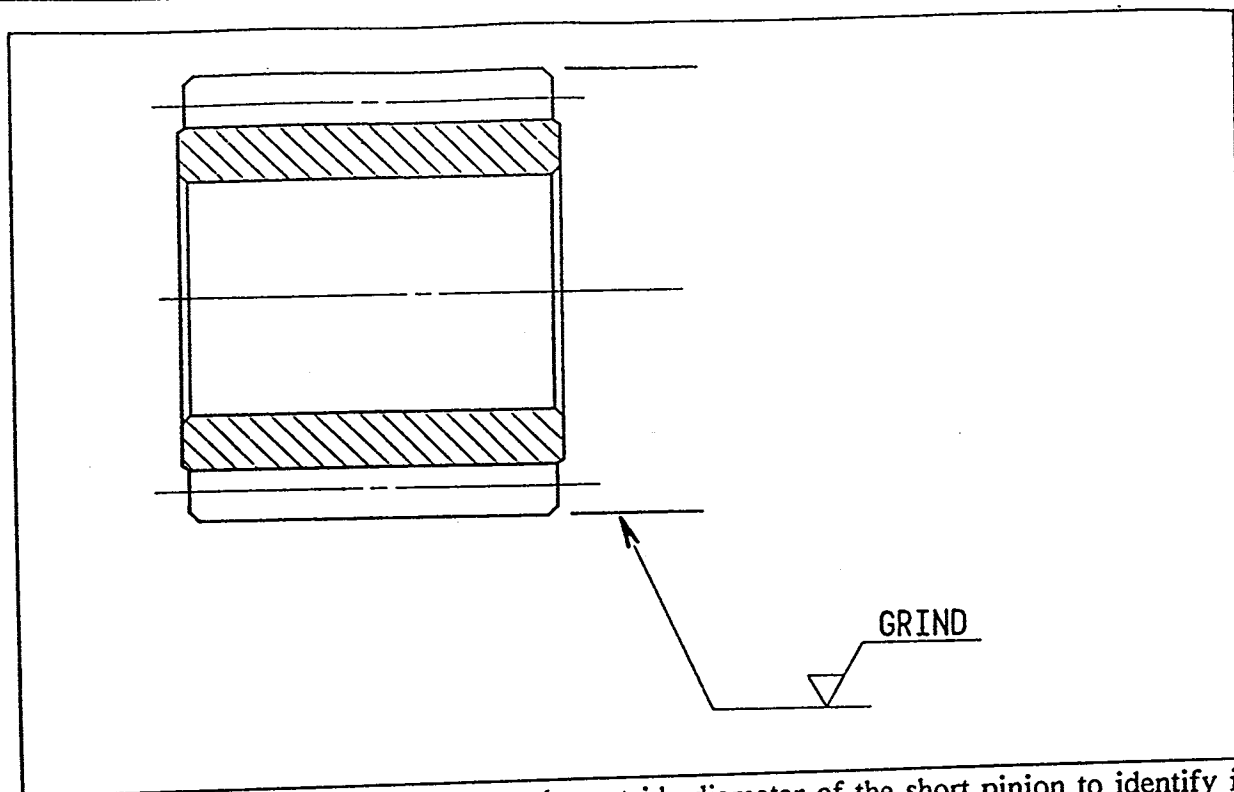
Figure 6 : Sketch of the grinding on the outside diameter of the short pinion to identify it as a new design pinion.

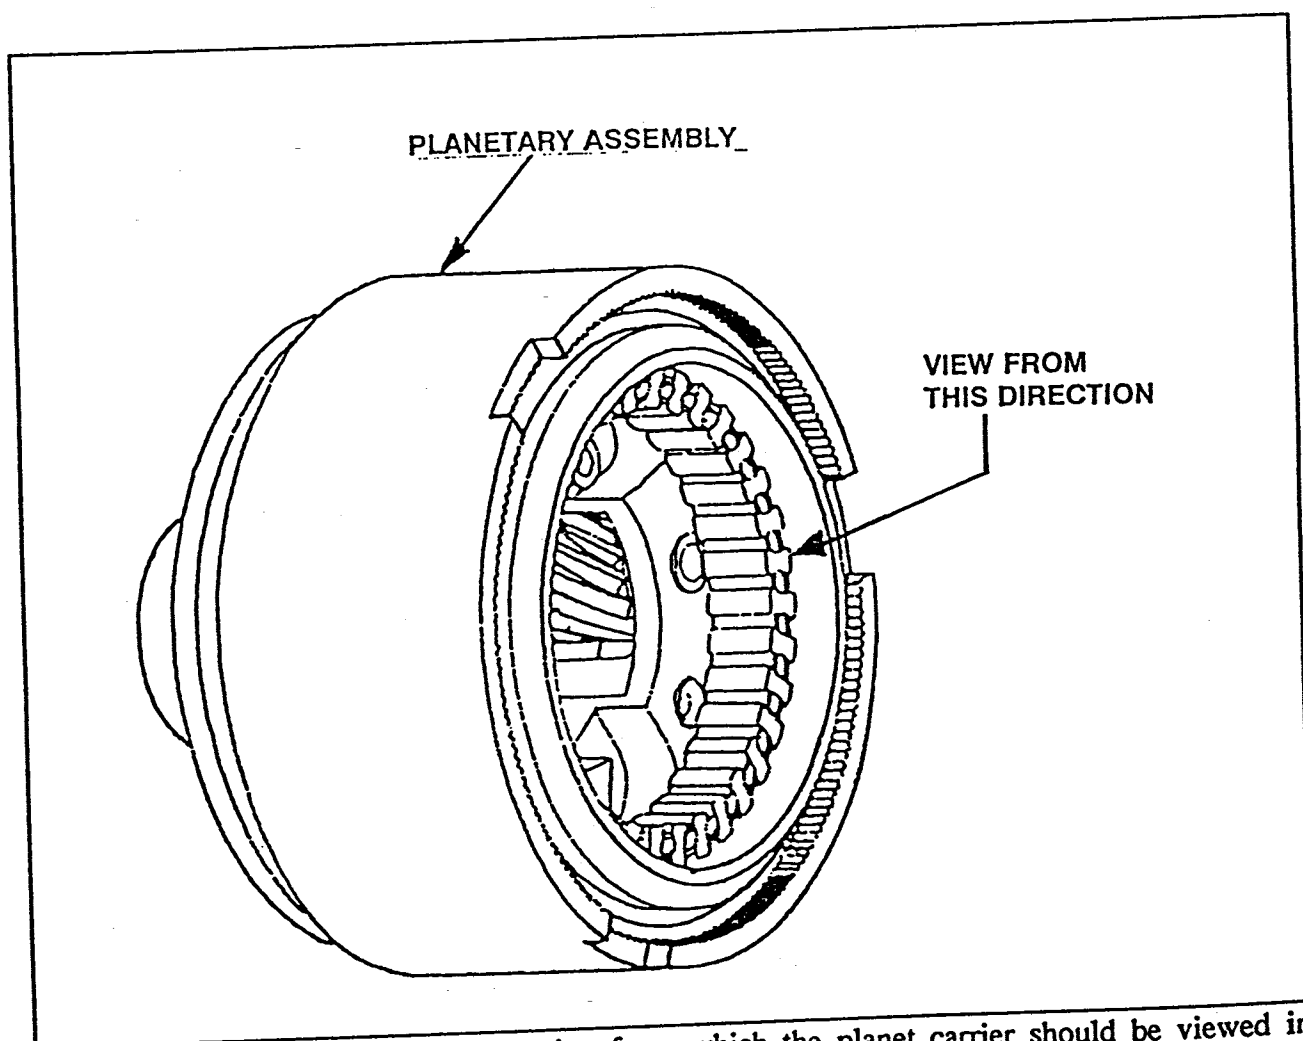
Figure 7 : Sketch showing the direction from which the planet carrier should be viewed in order to see the identification grooves on the long pinion.

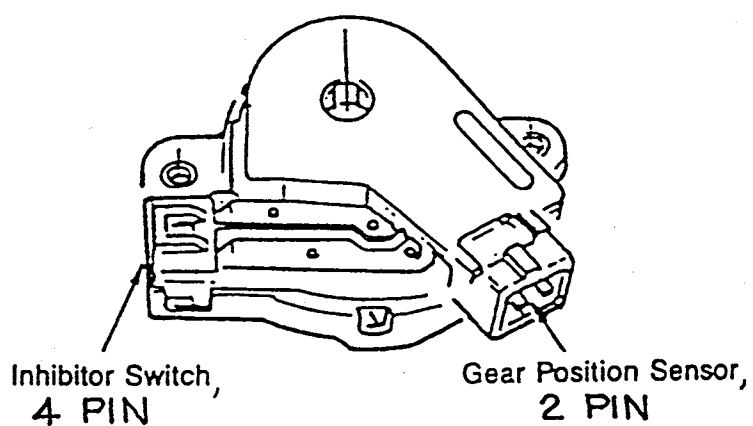
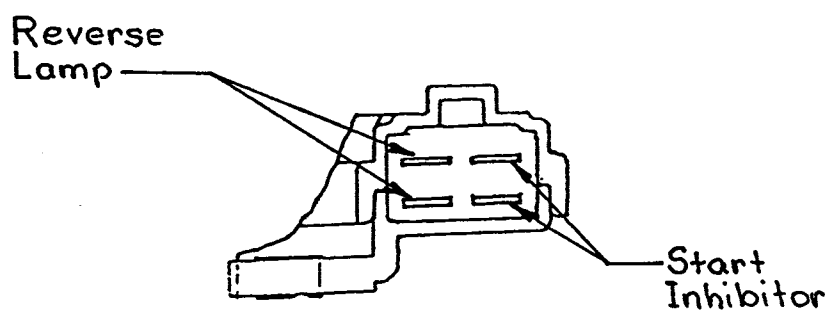
FIG. 1

- i) Gear lever was not in Park when codes were read.
- ii) Air conditioning or climate control was on/faulty when codes were read.
- iii) Check that inhibitor switch wiring is correctly fitted, (4 pin side).
- iv) Check that the inhibitor switch wiring fuse is OK.
- v) Check that the switch has continuity on 4 pin side (Figure 1).

SHIFT LEVER POSITION	RESISTANCE (OHMS)
Manual 1	1k - 1.4k
Manual 2	1.8k - 2.2k
Manual 3	3k - 3.4k
Drive	4.5k - 4.9k
Neutral	6.8k - 7.2k
Reverse	10.8k - 11.2k
Park	18.6k - 19k
